**SUBJ:** Air Conditioning – Cabin Pressure Control System

**SAIB:** AIR-20-17

**Date:** November 3, 2020

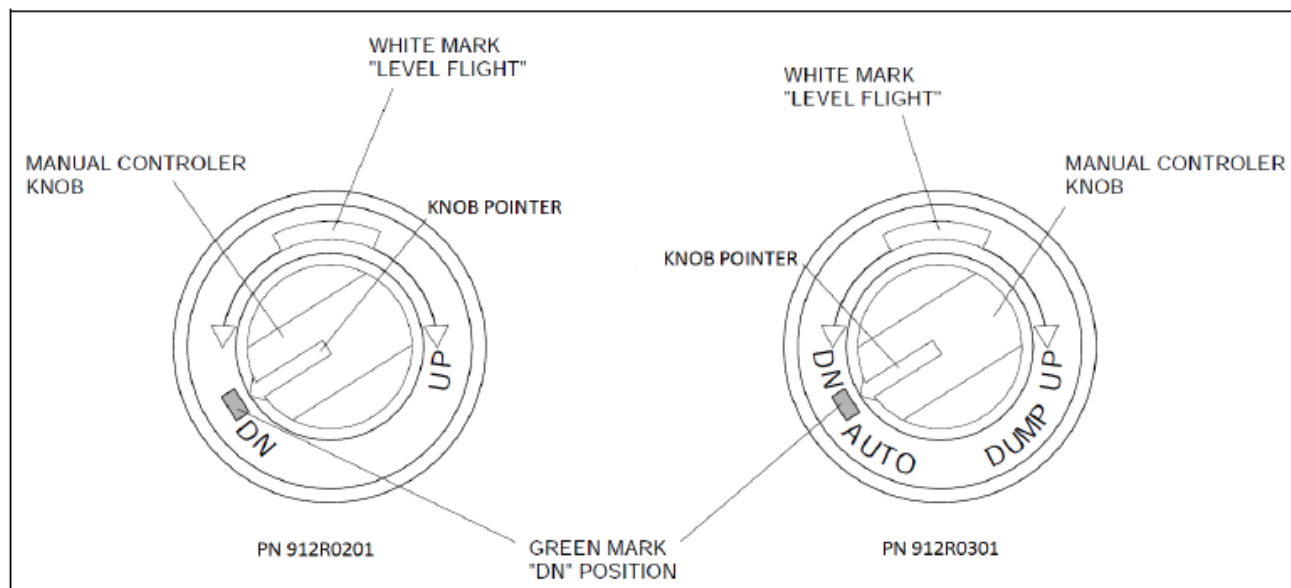
An ongoing investigation of both pressurization system failures revealed preliminary findings, which indicate that a faulty manual pressurization controller knob may have prevented the crew from setting the manual pressurization system correctly. This could result in the aircraft having a cabin pressure higher than the ambient pressure when landing at the airport and consequently could prevent the opening of the main entry door.

- 1- Visually inspect the manual pressure controller knob and panel face markings in the cockpit for obscured/erased paint markings. Ensure that the knob pointer line and panel face markings are clearly visible and legible. Panel face or controller knob obscured/erased markings can prevent the crew to accurately set the manual pressurization system;
- 2- Do a check of the manual controller knob (\*PNs 912R0201 or 912R0301, see Figure 1 below), as follows:
  - a. Make sure that the engines and auxiliary power unit (APU) are not in operation;
  - b. Turn the manual controller knob fully clockwise. When the knob pointer line approaches the 4 o'clock position ("UP" marking on the panel face), a detent spot (notch) should be felt in the movement of the knob;

- c. Turn the manual controller knob fully counterclockwise. When the knob pointer line approaches the 8 o'clock position ("DN" or "DN AUTO" green marking on the panel face, depending on PN 912R0201 or 912R0301, respectively), a detent spot (notch) should be felt in the movement of the knob.

If unreadable/obscured/erased markings are identified in the visual inspection, or if too much force is required to turn the knob, or if either of the detent spots are not felt, replace the part.
